# Manhole Inspection Summary

Manhole # S11KK\_001MH

**Location** Address: **2100 N ROSEDALE ST** Cross Street: **WINDSOR AVE**

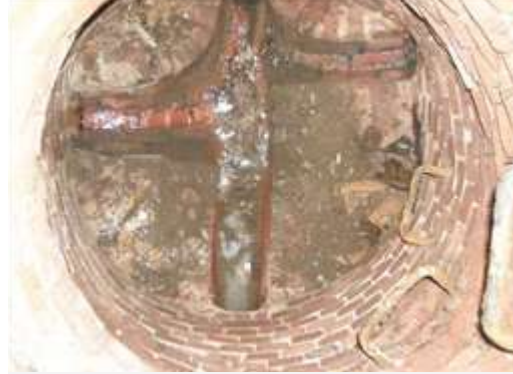
Top View

BENCH DEBRIS

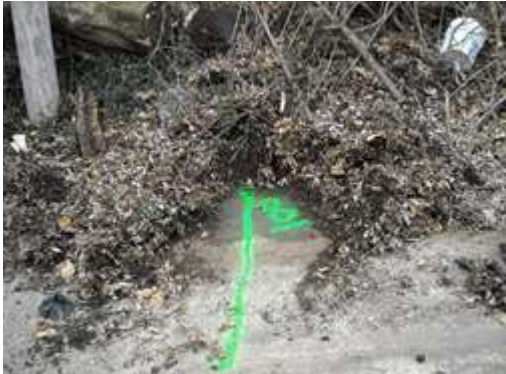
EXPOSED IN HILLSIDE

MANHOLE NEEDS TO BE RAISED  
PRIOR TO INSPECTION DUE TO  
THREAT OF HILLSIDE COLLAPSE

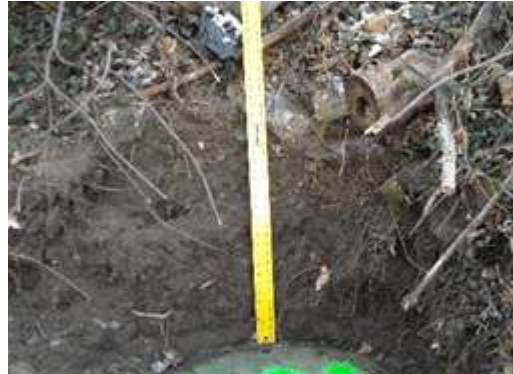
BELOW GRADE BY 33" AT BACK

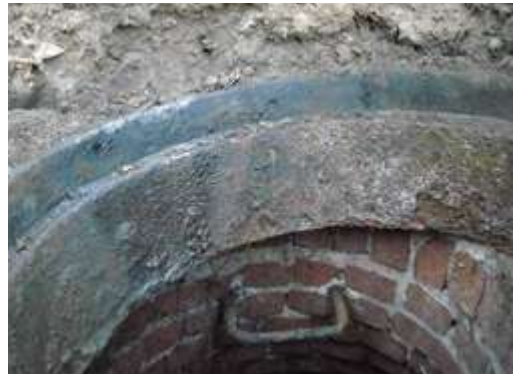
EVIDENCE OF INFLOW DUE TO  
SHEETING WAS BELOW GRADE IN  
HILLSIDE

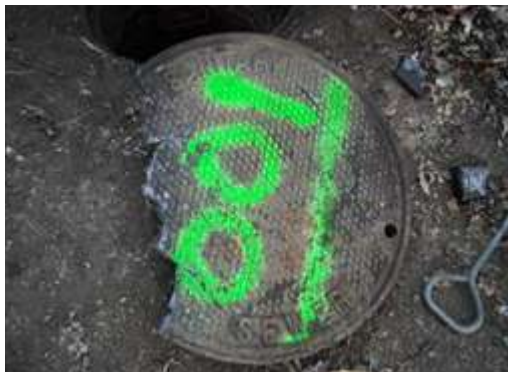
### BROKE OPEN

HAD TO BREAK LID OPEN AFTER  
CRACKING

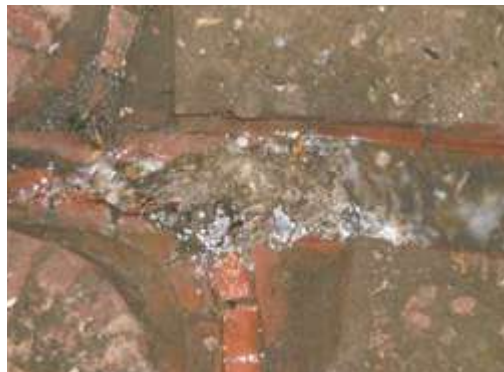
### Defect 7

DEBRIS IN CHANNEL

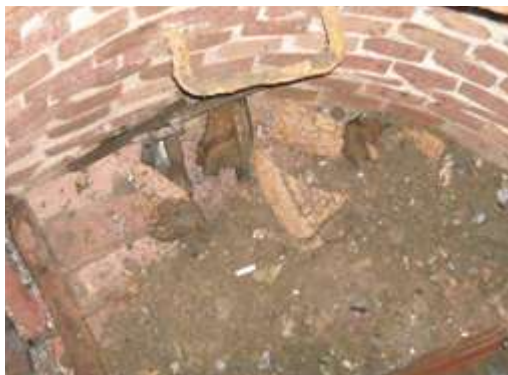
### Defect 6

**Bench** ☒ Exists Material: **Brick** ☐ Parged  
Condition: ☐ Sound ☐ Cracked ☐ Root Intrusion ☐ Deteriorated ☐ Leaks ☒ **Debris**

DEBRIS ON BENCH

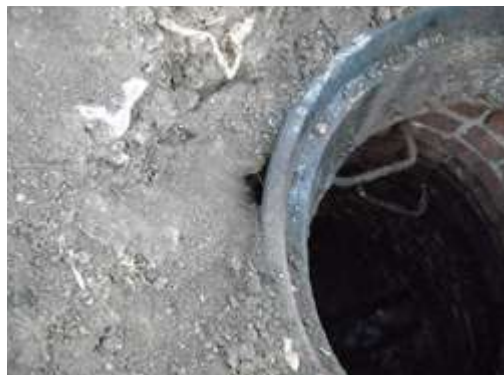
### Defect 4

**Frame** Offset: **4** (in.) Condition: ☐ Sound ☐ Cracked ☒ **Leaks**

FRAME LEAKS THROUGH HOLE

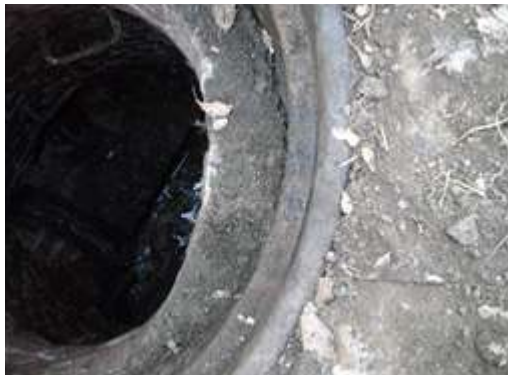
### Defect 3

4" FRAME ADJUSTMENT

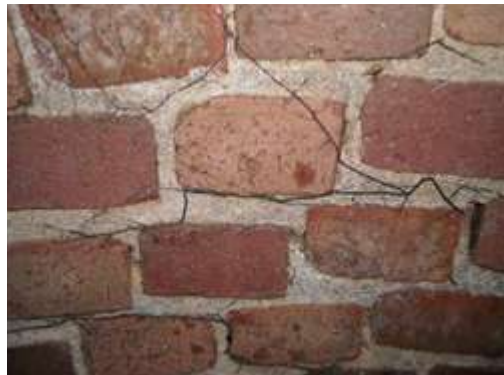
### Defect 2

**Barrel** Material: **Brick** ☐ Parged  
Shape: **Circular** Diameter: **42** (in.) Length: (in.)  
Condition: ☐ Sound ☐ Cracked ☒ **Root Intrusion** ☐ Loose Brick ☐ Deteriorated  
Infiltration: ☐ None ☐ Joint ☐ Cracks ☒ **Mortar** ☐ Roots ☐ Wall

ROOT INTRUSION IN BARREL WALL,  
ALSO MORTAR IS MISSING

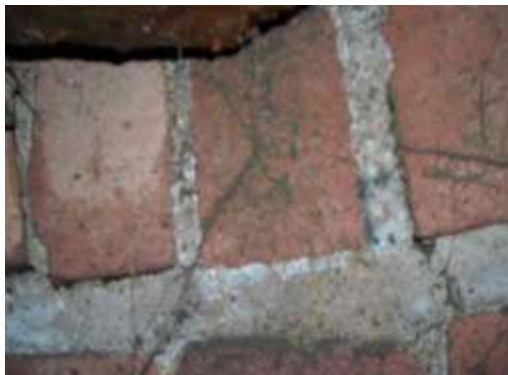
Defect 1

**Corbel** Material: **Brick** ☐ Parged Type: **Concentric/Eccentric**  
Condition: ☐ Sound ☐ Cracked ☒ **Root Intrusion** ☐ Loose Brick ☐ Deteriorated  
Infiltration: ☒ None ☐ Joint ☐ Cracks ☐ Mortar ☐ Roots ☐ Wall

ROOT INTRUSION BELOW FRAME IN CORBEL

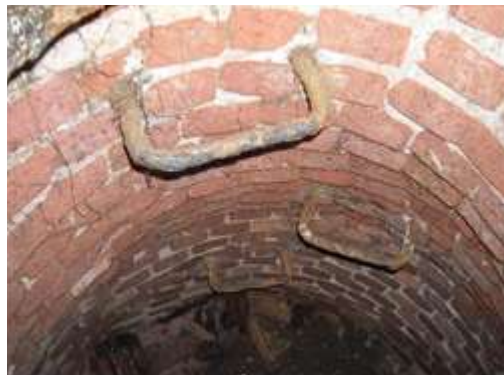
Defect 5

**Steps** Count: **3** Missing: **0** ☒ **Corroded**

STEPS ARE SHOWING BEGGINING  
SIGNS OF CORROSION

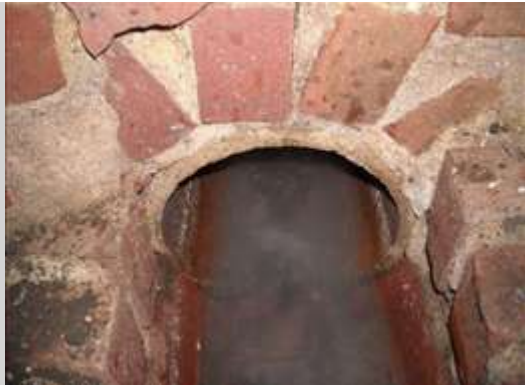
6 O'Clock Inflow

Deposits: ☐ None ☐ Mud ☒ **Sludge** ☐ Debris ☐ Grease

Silt Depth: **3** (in.) Deposits Extent: **Light**
